## TEST REPORT

No. : XMIN2305000337CM01-1\_EN

Sample Name : SPC 010  
Manufacturer : EVERLASTING BASE SDN BHD  
Material : SPC

### Summary of Results:

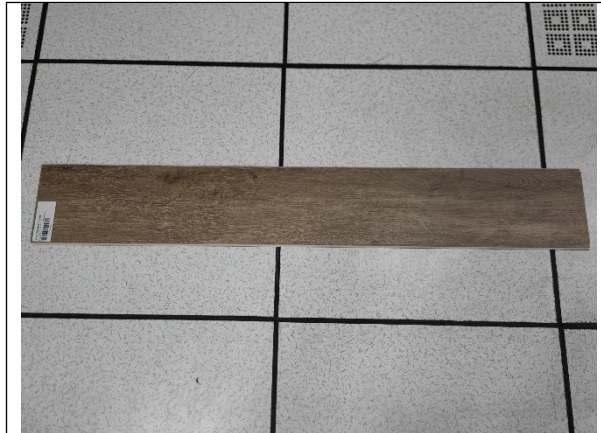
### Original Sample Photo:

Sample Description: Flooring, See photo
